Re: Code Violation
129 W. 1st St.
Salida, Co. 81201

MEMORANDUM

RE: **Unique Theater Inspection**
SGM Project No. 2008-213.001 Phase 023

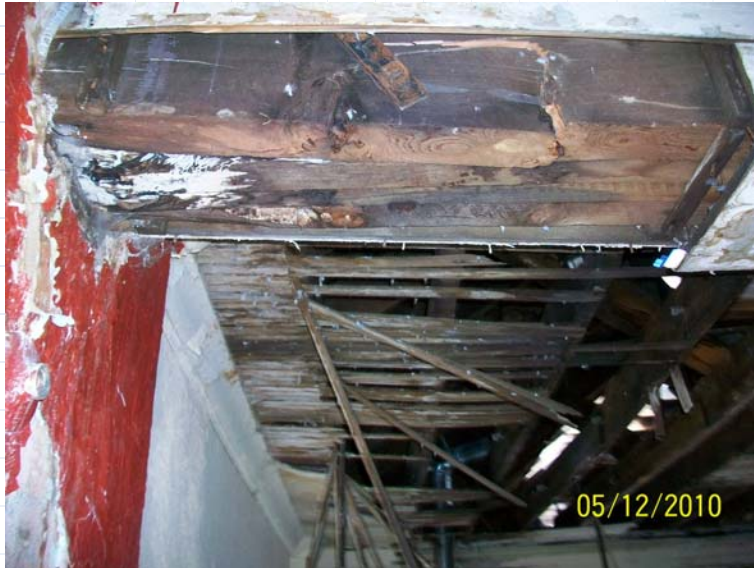
Truss #1 is a heavy timber truss, in which the bottom chords are deteriorated and cracked near the bearing adjacent to the wall. As pointed out in Ref. 1, this area is a high stress region. Since this truss is not shored, it must support all dead loads (truss & roofing) currently in place. At the time of our inspection, no live loads were present (snow). Due to the extent of the cracking and deterioration observed, and amount of vertical deflection (sag), we believe this member has significantly less capacity than required, and is at moderate risk of collapse with dead load only.

Truss #1, South Bearing

- With a reduced section due to cracked and deteriorated members, we calculate a load/strength ratio of 2.55; Criteria 1 allows a maximum ratio of 1.33, which is less than the calculated value of 2.55.
- Considering the area of maximum stress is very near the bearing area, we believe Truss #1 & #6 meet Criteria 2 as well, in that it is likely to fail and therefore collapse.
- We find no definitive connection between the truss and the wall, whereby it is not capable of resisting a negative wind pressure (suction) applied to the exterior wall, thereby meeting Criteria 3.
- Due to the amount of water damage and deterioration at the bearing, the truss is likely to collapse, thereby meeting Criteria 4.

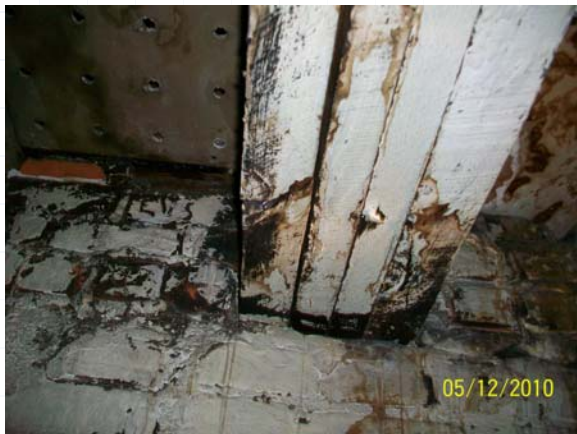
Similarly, Truss #6 exhibits cracking and deterioration at the south bearing. By observation, the amount and extent of cracking and deterioration is not as severe as Truss #1; however the level of concern is not lessened.

Truss #6, South Bearing – note crack in bottom of left member

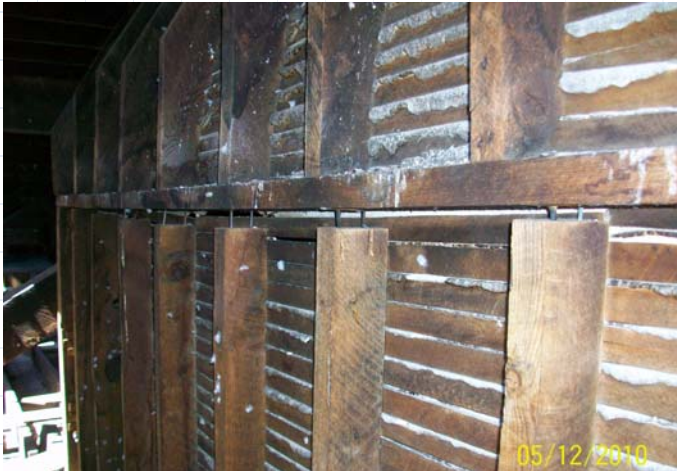
Between Truss #3 & #4, there is what appears to be a previous skylight in the center of the roof. This area is framed to allow a vertical shaft to extend from ceiling to roof. We observed the framing (beam and joists) on the south side of the shaft to be severely cracked and deflected.

Since this area is supported by secondary framing, we believe a failure would result in a portion of the ceiling, and possibly roof, to collapse into the main area.

Skylight wall –note gap where studs are pulling away from plate due to cracked beam

- Since the supporting beam for the skylight wall is severely cracked, the load/strength ratio is greater than 1.33, since the cracked member calculates to have no strength, is likely to fail, and therefore meets Criteria 1 and Criteria 2.

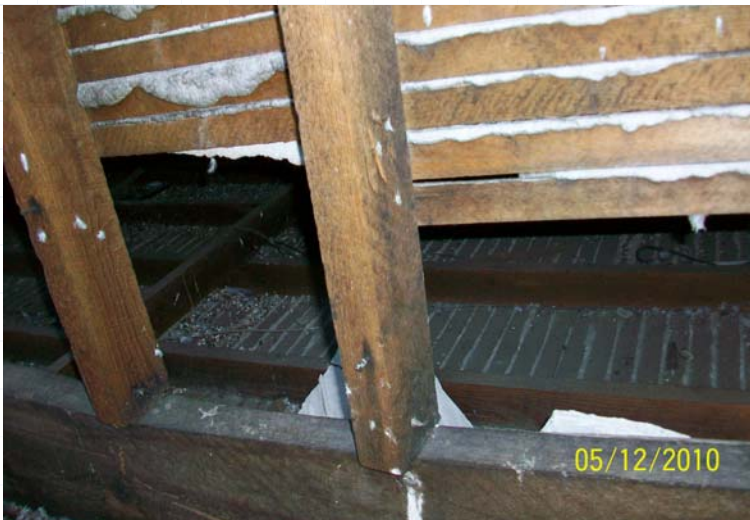
Beam supporting skylight wall – note crack in beam at lower left allowing excessive deflection

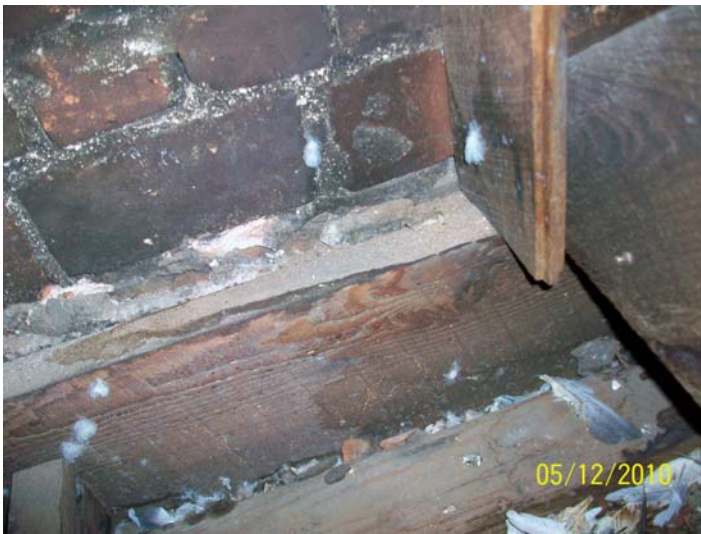
I observed no original connection between the main timber trusses to the masonry wall, nor of the roof or ceiling to the wall. A later retrofit installed steel plate brackets which were bolted to the wall and the bottom of the trusses, located at Truss #'s 3, 4, & 5. When the bracket was exposed at the north bearing for Truss #5, the plate was observed to be bent and to have pulled away from the face of the wall. The retrofitted brackets undoubtedly provide some tie to the

walls, but due to the type and location of these ties, we are of the opinion that this diaphragm/shear wall system will not resist the design wind or seismic events.

Ceiling rim joist – no attachment observed

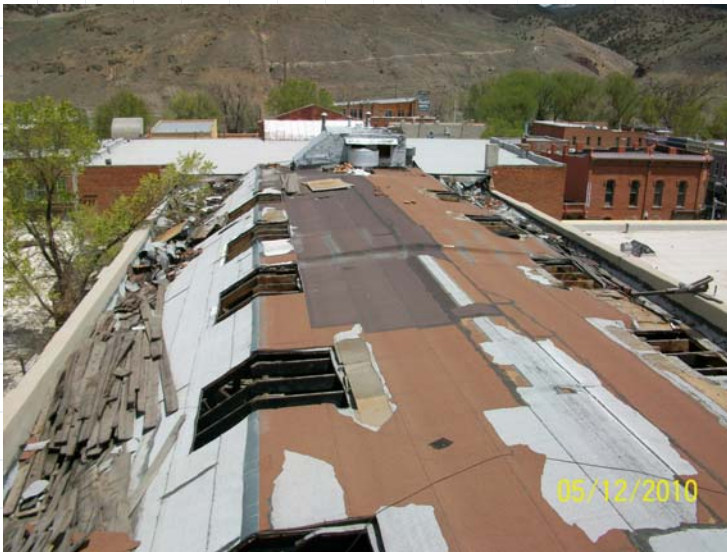
There are areas that allow moisture to enter the building. We believe this infiltration has and will continue to jeopardize the integrity of the building. Open areas on top of walls allow moisture to infiltrate between multiple brick wythes that during winter months, can freeze and pry the wall

apart, causing structural instability. Moisture infiltration into main truss bearings is degrading the bearing areas of the trusses. It is not known exactly how advanced this degradation is, but certainly this is a near-term concern.

Penetrations in the roof to install shoring remain, allowing moisture to enter the building

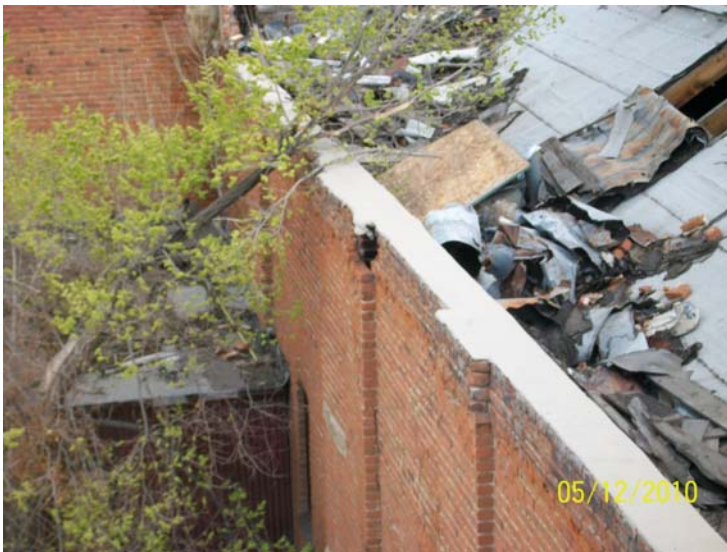
Hole in top of wall allows water to enter cavity between wythes of brick
